# Manhole Inspection Summary

Manhole # S33AA2010MH

Insp Date: **4/18/07 10:07 AM**

**Location** Address: **5401 SPRINGLAKE WAY**

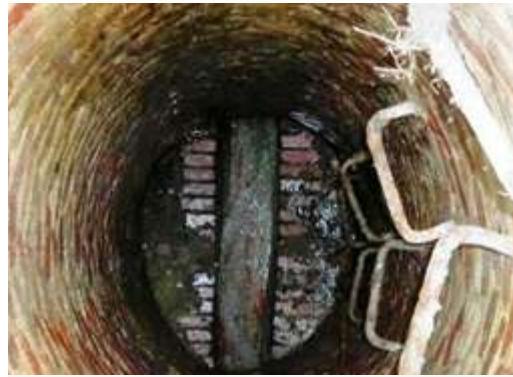
Top View

Corroded steps. Bench debris.

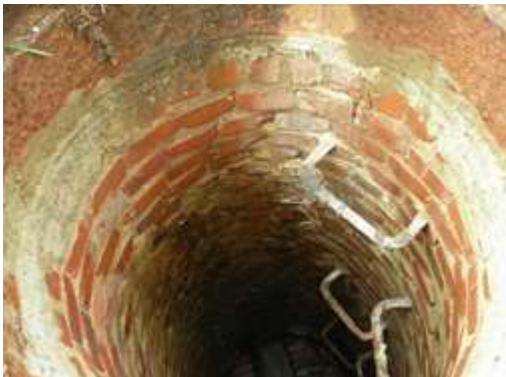
Defect

Adjustment deterioration and infiltration.  
Corbel infiltration - other side.

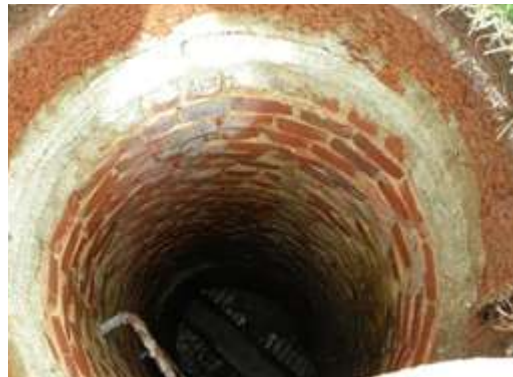
Defect

Adjustment deterioration and infiltration.  
Corbel infiltration.

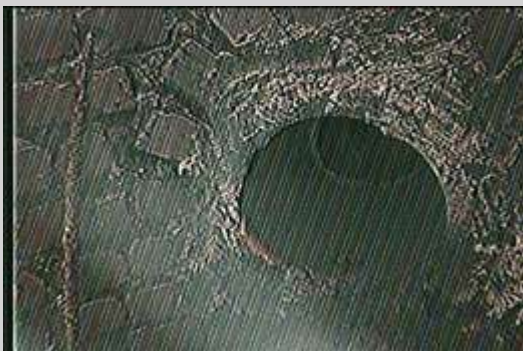
### 10 in. Circular Gravity Sewer Pipe In @ 6 O'Clock

Infiltration: **Evidence** Pipe Seal Cond: **Cracked**

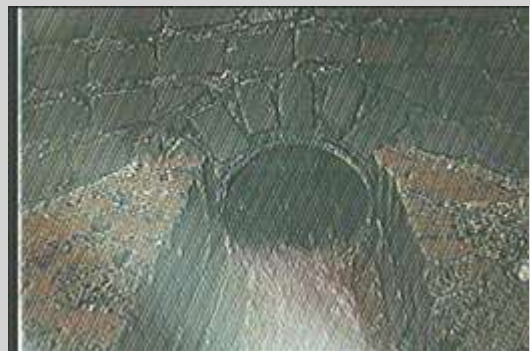
### Drop In @ 6 O'Clock

Barrel deterioration and infiltration. Channel deterioration.
